UNITED STATES
DEPARTMENT OF THE INTERIOR
GEOLOGICAL SURVEY

FLOODS FROM DAM FAILURES

By John E. Costa

Open-File Report 85-560

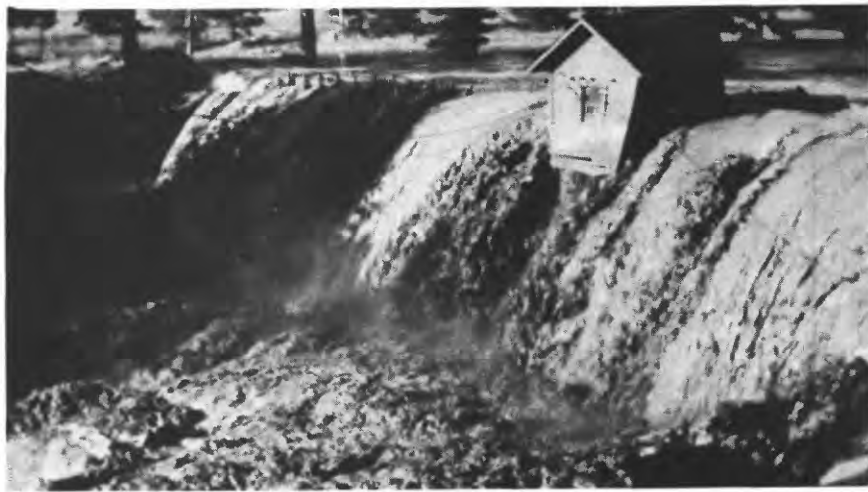
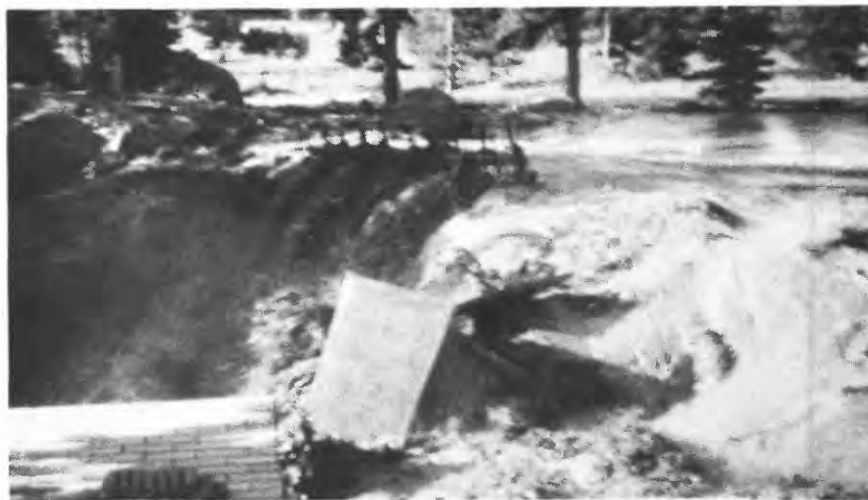
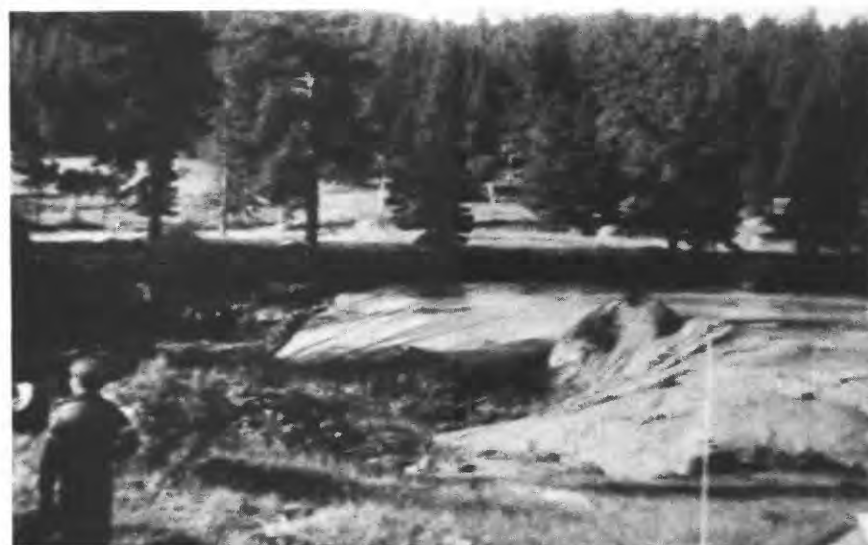
The Malpasset Dam was a high concrete-arch structure and Cascade Lake Dam was a concrete-gravity dam. These kinds of dams are more susceptible to rapid failure than most of the other types. The sequence of the toppling failure of Cascade Lake Dam, Colorado, is shown in figure 6. The inflow flood peak leading to the failure was 45 percent of the outflow peak following the failure.

Figure 6. Photographs showing sequence of Cascade Lake Dam failure, Colorado, July 15, 1982 (from Jarrett and Costa, 1985).

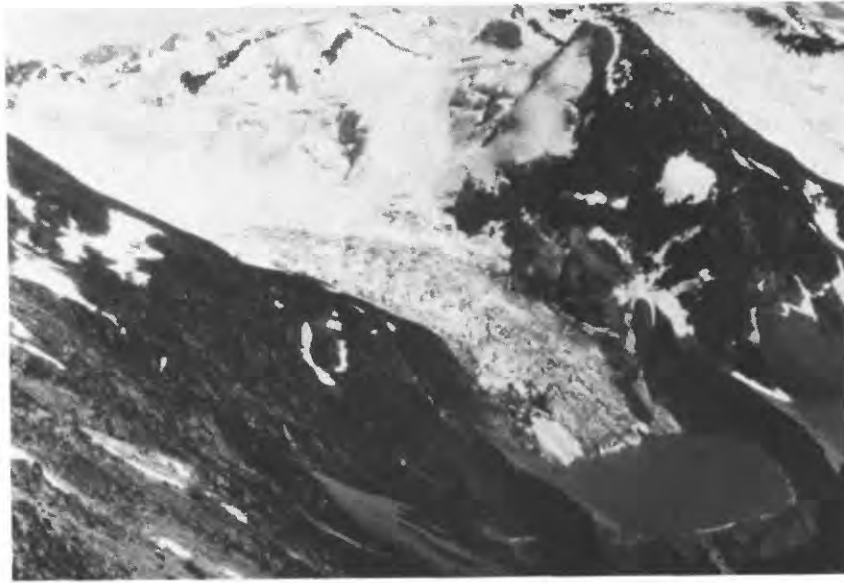
Figure 10. A. Aerial photograph of Nostetuko Lake and Cumberland Glacier, British Columbia, Canada, in July, 1977. (Photo by J. M. Ryder, courtesy of Michael Church).

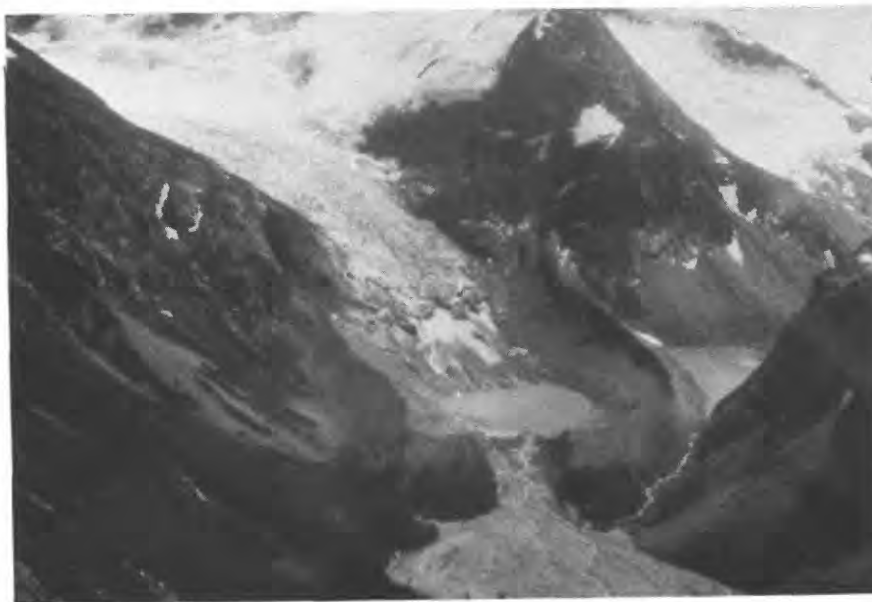
B. Aerial photograph of Nostetuko Lake and Cumberland Glacier, British Columbia, Canada, in August, 1983, after the morainal dam was breached. (Photo courtesy of Michael Church).

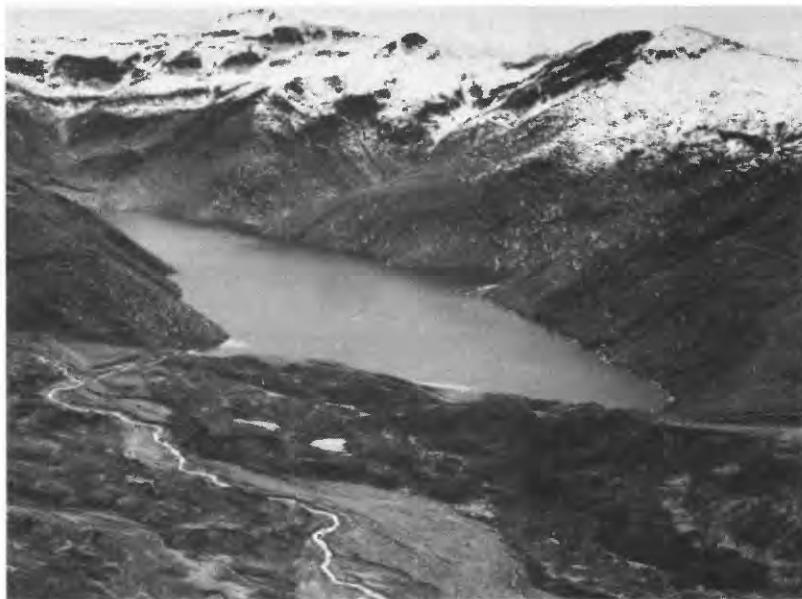
Figure 11. Photograph of Castle Lake, Mount St. Helens, Washington, dammed by a debris avalanche deposit. Debris avalanche moved from left to right in photo. An artificial spillway was cut into the right embankment. (April, 1984) (Photo courtesy of R. L. Schuster).

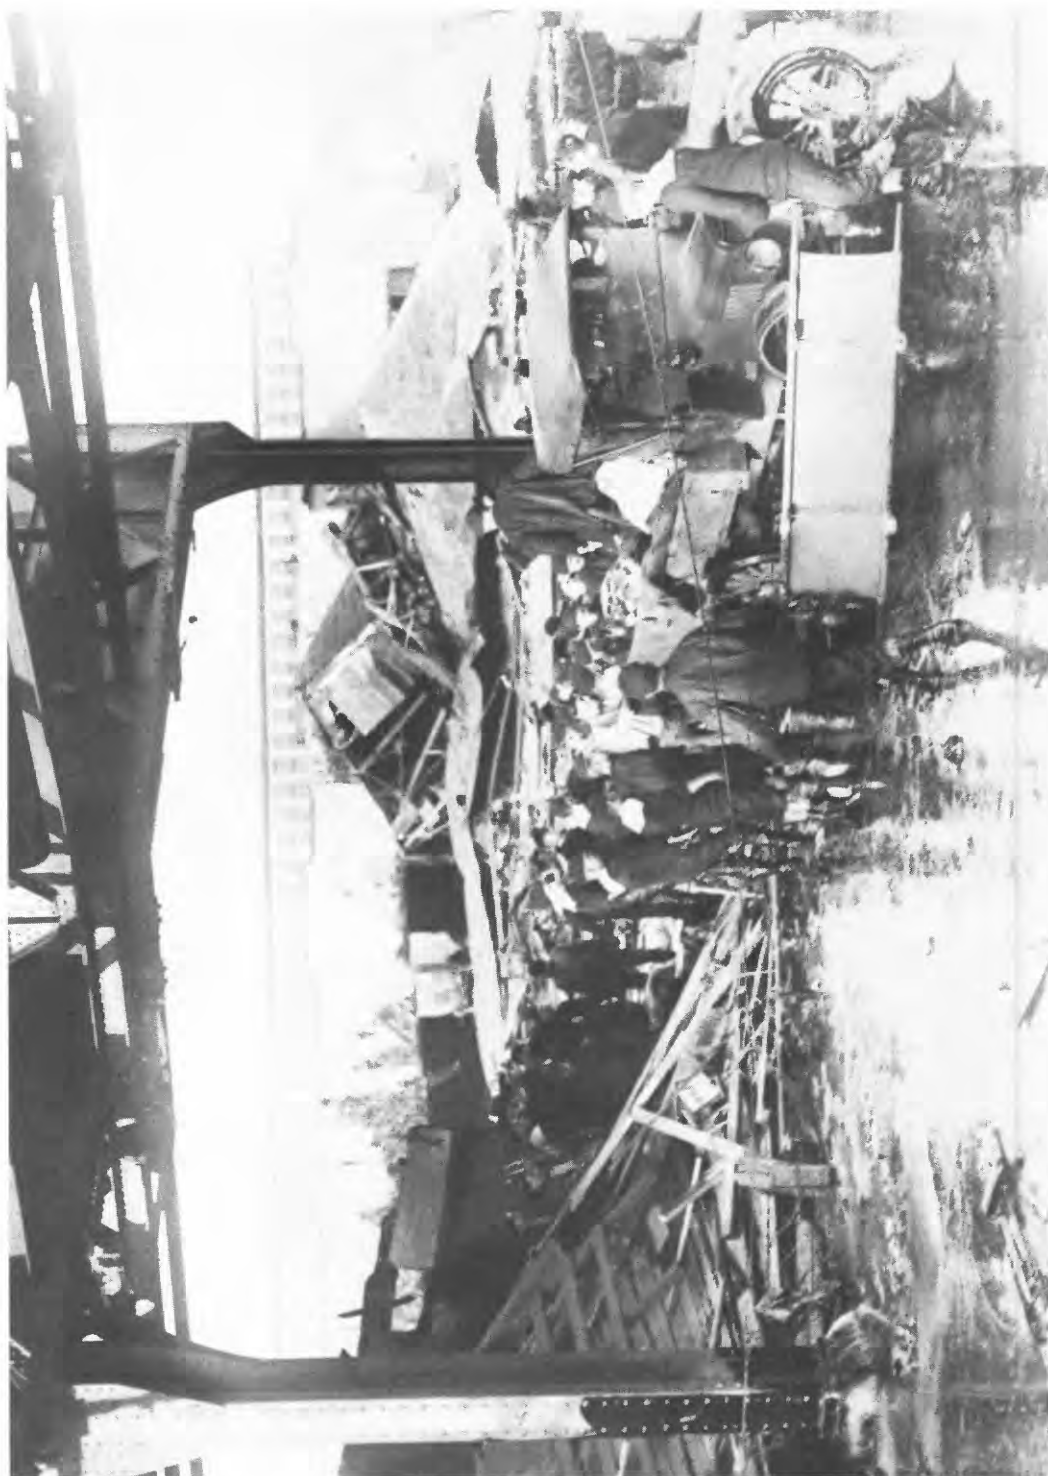
Figure 14. Damage from collapse of giant molasses tank at Boston harbor, January 15, 1919. View along Atlantic Avenue. Photo courtesy of the Boston Public Library, Print Department.

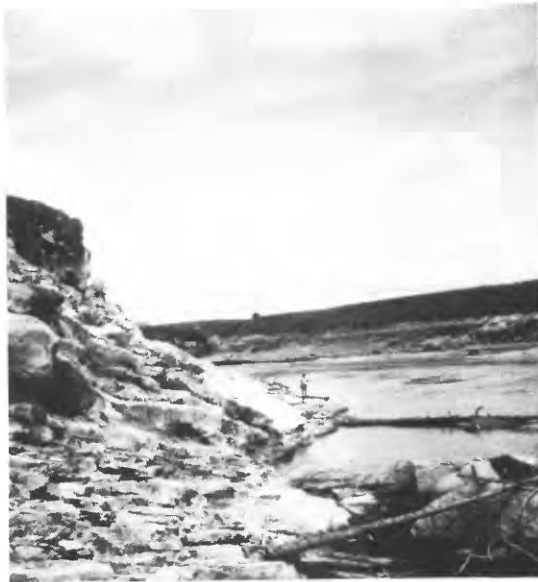
Following the Teton Dam failure in 1976 in Idaho, the flood waters eroded about one meter of weathered volcanic rocks in the channel, destroyed all trees and vegetation, and stripped topsoil along an 8-km reach of canyon below the dam (fig. 15) (Ray and Kjelstrom, 1978). During the Buffalo Creek, West Virginia dam-break flood, sandstone bedrock along valley walls was eroded (Davies and others, 1972).

Figure 15. Photograph of Teton River valley at Newdale, Idaho showing area of bedrock erosion along the left bank after the Teton Dam failure in 1976. Person in center of photograph for scale.
